## **POST-FLOOD REHABILITATION OF AFFECTED COMMUNITIES BY NGOS IN PUNJAB, PAKISTAN-LEARNING LESSONS FOR FUTURE**

### **Abstract**

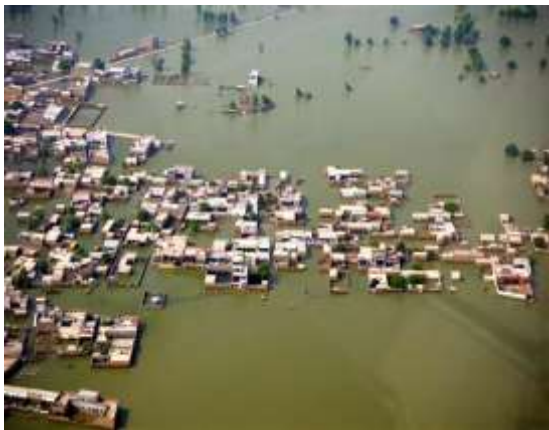
Figure 1: Aerial view of Rajanpur submerged in 2010 flood waters  
Source: Associated Press, 2012.

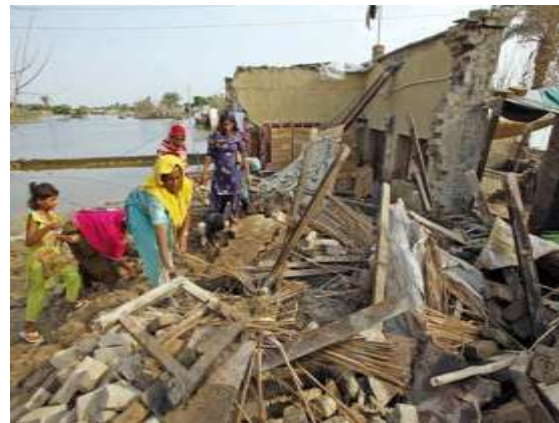
Figure 2: Villagers recover goods from their houses destroyed by 2010 flood in Muzaffargarh  
Source: Daily Times, August 24, 2010

Owing to extremely deprived socio-economic characteristics of the flood affected families, it is unfortunate to know that most of their houses were poorly constructed using mud as a bonding agent even with baked bricks (See Table 2). Brick masonry with mud cannot sustain for a few days in three feet stagnant flood water. Such structures are called ‘katcha’ and ‘semi-pacca’ in local language. Internationally, these may be termed as slums or shanty towns like settlements. Such houses could not sustain despite the fact that the walls of 100% houses in Miani Mallah and 55% in Noor Ghazi had been constructed on foundations. But, the foundation design and construction was not according to the standards normally practiced in the cities of Punjab [22]. Poorly built houses with weak brick and mortar walls without structural connection to foundations and lack of drainage system also caused heavy losses in Tsunami hit areas in other developing countries [22, 23].

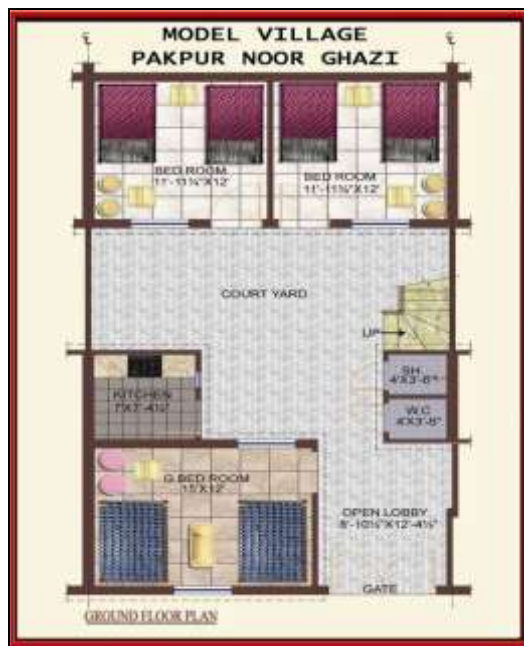
Fig. 4 House Design for Basti Pakpur Noor Ghazi  
Source: (<http://www.amcpakistan.org>)

The affected families living in the Noor Ghazi are given one bedroom houses constructed on 1360 sq. ft. plots (5 Marla) (Figure 4). Those living in Miani Mallah got 2 bedroom houses on varying sizes of plots ranging from 1360 to 2720 sq. ft. (Figure 5). Factors like the area of the house owned by the affected family before flood or the amount of land donated by the government and availability of finances contributed toward this variation in number of rooms and plot sizes. However, the designs of the houses constructed in both the case study settlements provide for future addition of rooms. Further, the houses have been provided with kitchens attached to the veranda of the houses keeping in view the cultural setting of the villagers but some houses have separate kitchens. Separate bath and toilets are also provided in every house.

Materials used for the construction of houses include baked bricks, cement sand mortar. It is good to note that pre-cast cement-concrete slabs were used for the construction of roofs. Doors and windows of houses in both the settlements were made up of steel. Overall, the houses are constructed according to the design considerations and recommendations of National Disaster Management Authority of Pakistan. Relevant literature suggests that house buildings provided with reinforced cement concrete roofs and brick walls having structural connection with foundations can resist the impact of flood or at the most cause slight or non-structural damages [24]. As far as the satisfaction of the beneficiaries is concerned, almost 100 percent interviewed families living in the case study settlements are satisfied with the design and construction quality of newly constructed houses. Nevertheless, some of the interviewees also showed their concern over the small size/covered area of the houses. They had to add one to two bedrooms on self-help basis.

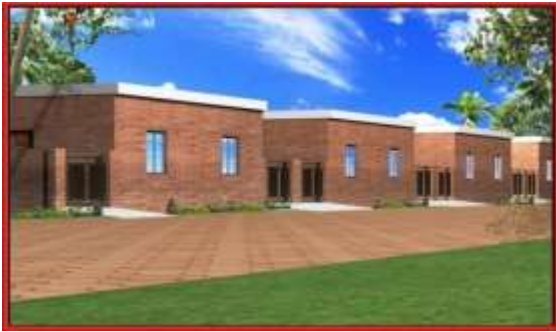
Fig. 6 3D View of houses in Noor Ghazi  
(Source: <http://www.pakpur.org/plans.php>)

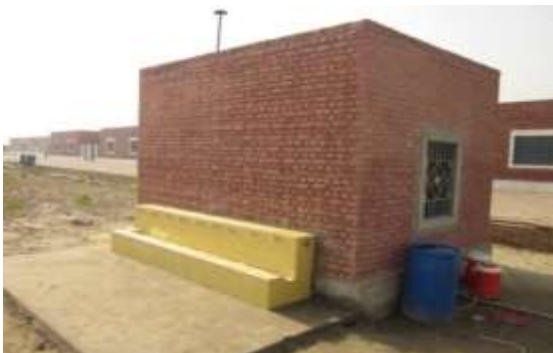
Fig. 8 Water filtration plant in Noor Ghazi  
Source: Photograph by the Authors, 2011

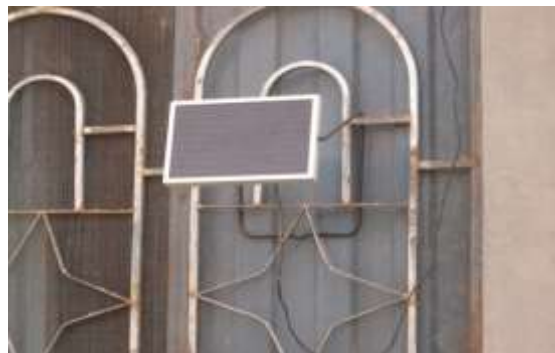
Fig. 12 Solar Cells outside houses in Noor Ghazi  
Source: Photograph by the Authors, 2011

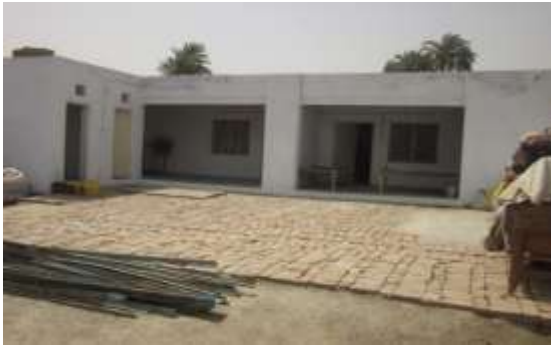
Fig. 14 Two room house in Miani Mallah  
Source: Photograph by the Authors, 2011

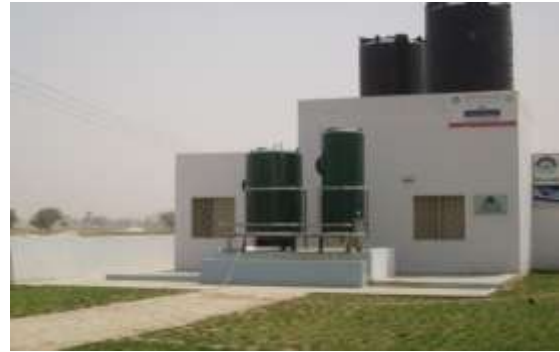
Fig. 18 Water filtration plant in Miani Mallah  
Source: Photograph by the Authors, 2011

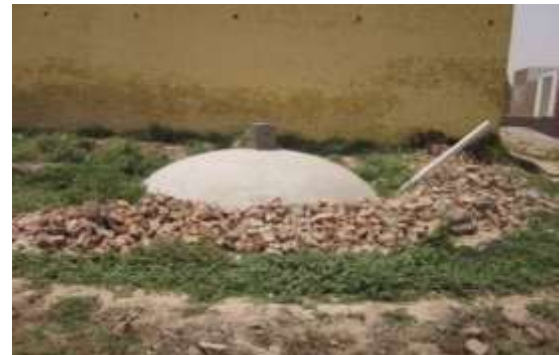
Fig. 20 Biogas plant in Miani Mallah  
Source: Photograph by the Authors, 2011
