**Post-Flood Rehabilitation of Affected Communities by NGOs in Punjab, Pakistan-
Learning Lessons for Future**

O. Nadeem^{1}, A. Jamshed², R. Hameed¹, G. A. Anjum¹, A. Khan³*

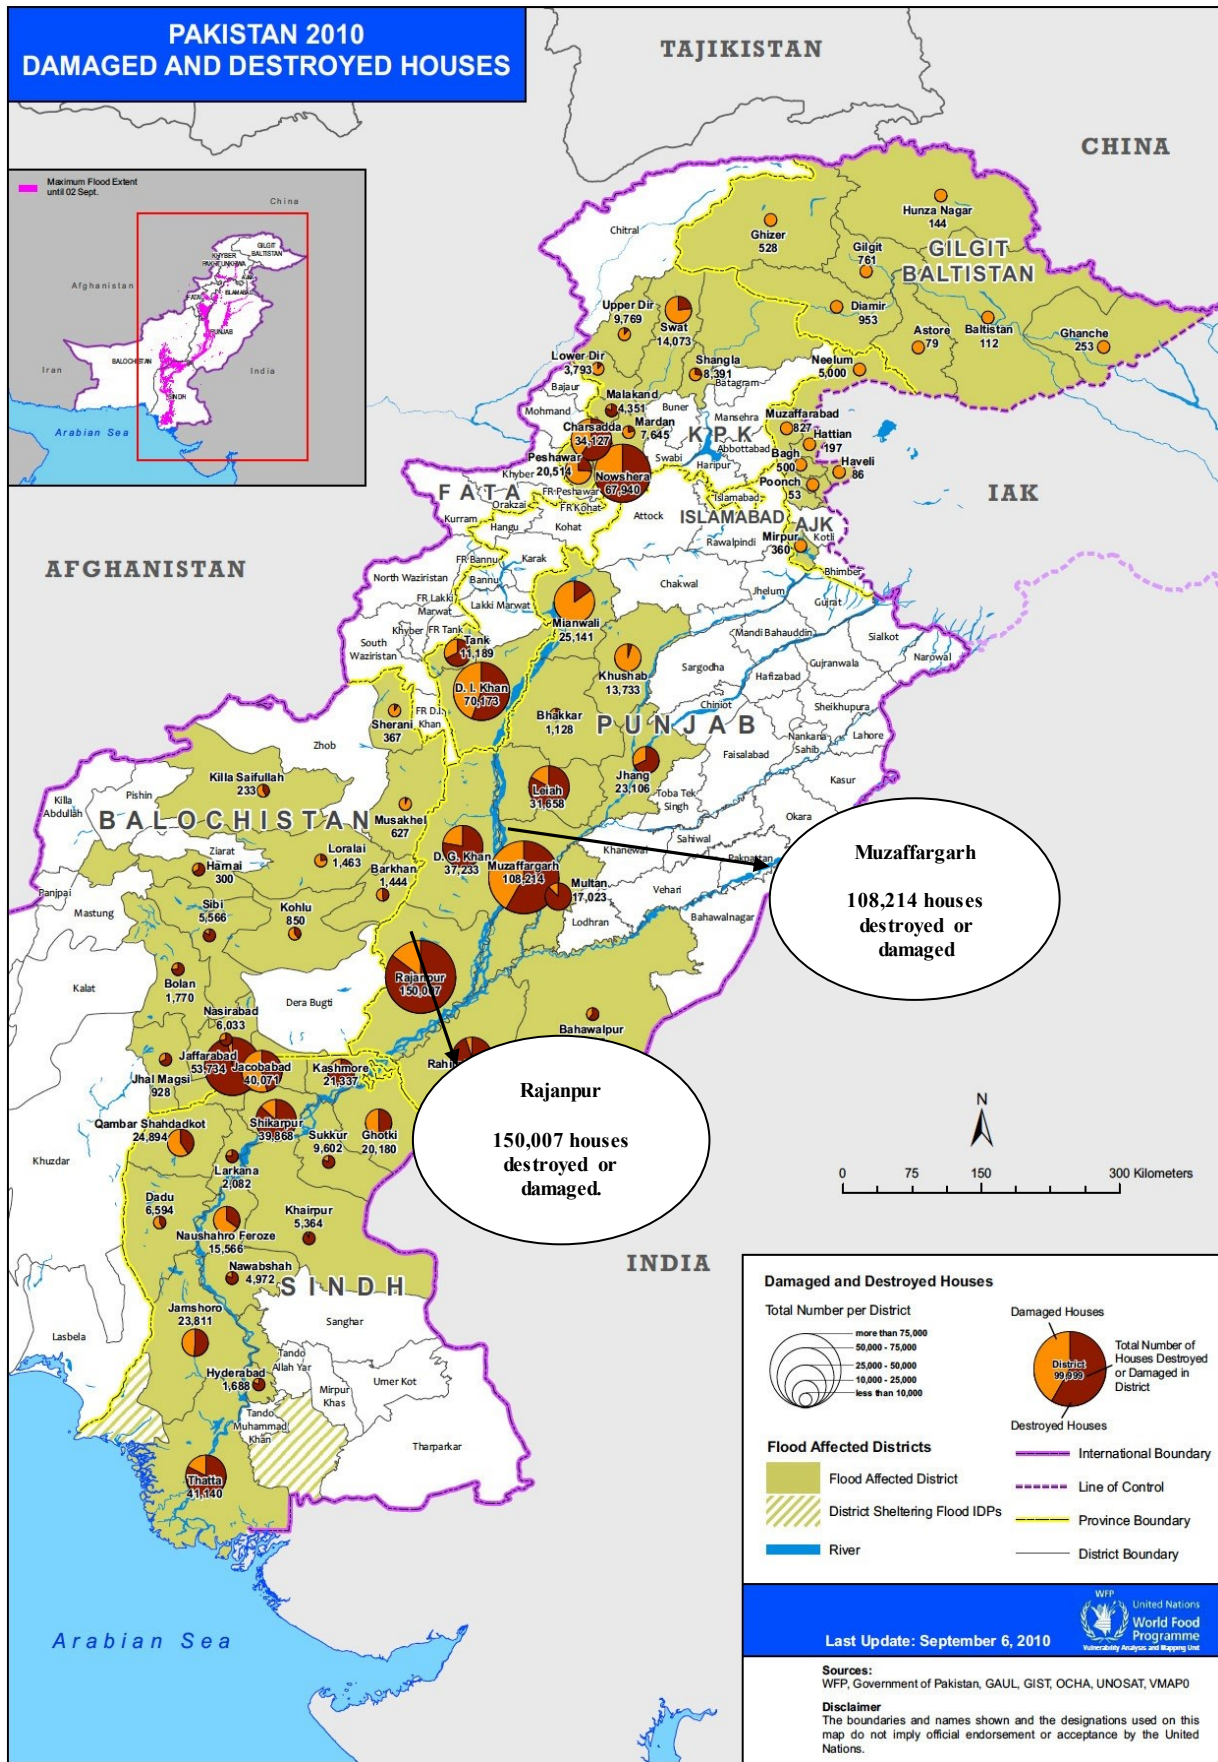
Figure 3: Number of destroyed houses and location of case study districts (Source: WFP, 2010).

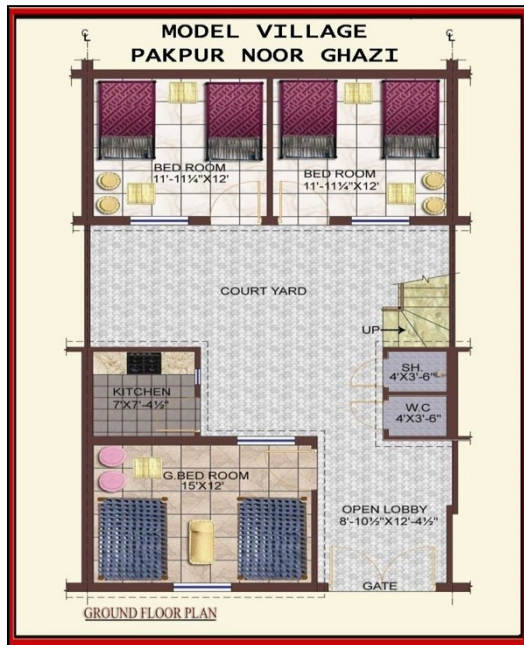
Fig. 4 House Design for Basti Pakpur Noor Ghazi
Source: (<http://www.amcpakistan.org>)

The affected families living in the Noor Ghazi are given one bedroom houses constructed on 1360 sq. ft. plots (5 Marla) (Figure 4). Those living in Miani Mallah got 2 bedroom houses on varying sizes of plots ranging from 1360 to 2720 sq. ft. (Figure 5). Factors like the area of the house owned by the affected family before flood or the amount of land donated by the government and availability of finances contributed toward this variation in number of rooms and plot sizes. However, the designs of the houses constructed in both the case study settlements provide for future addition of rooms. Further, the houses have been provided with kitchens attached to the veranda of the houses keeping in view the cultural setting of the villagers but some houses have separate kitchens. Separate bath and toilets are also provided in every house.

Materials used for the construction of houses include baked bricks, cement sand mortar. It is good to note that pre-cast cement-concrete slabs were used for the construction of roofs. Doors and windows of houses in both the settlements were made up of steel. Overall, the houses are constructed according to the design considerations and recommendations of National Disaster Management Authority of Pakistan. Relevant literature suggests that house buildings provided with reinforced cement concrete roofs and brick walls having structural connection with foundations can resist the impact of flood or at the most cause slight or non-structural damages [24]. As far as the satisfaction of the beneficiaries is concerned, almost 100 percent interviewed families living in the case study settlements are satisfied with the design and construction quality of newly constructed houses. Nevertheless, some of the interviewees also showed their concern over the small size/covered area of the houses. They had to add one to two bedrooms on self-help basis.

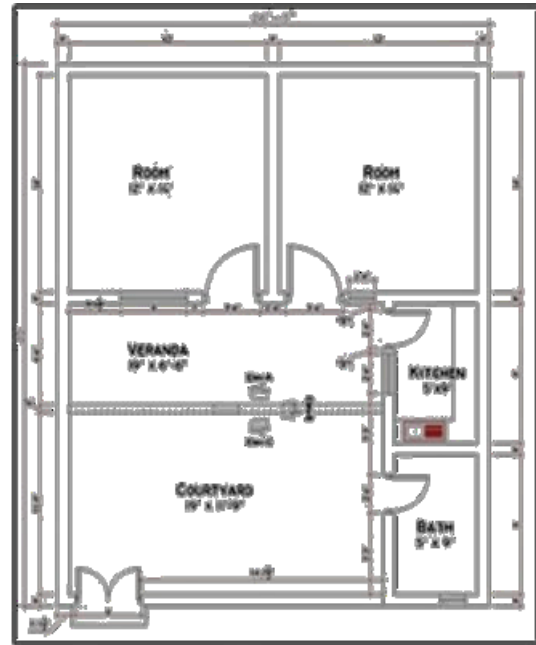
Fig. 5 House Design for Basti Miani Mallah
Source: Sukh Chayn Housing Estate

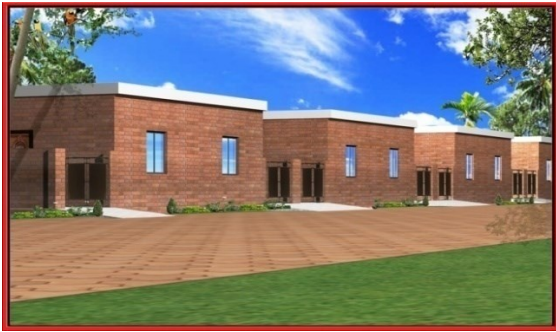
Fig. 6 3D View of houses in Noor Ghazi
(Source: <http://www.pakpur.org/plans.php>)

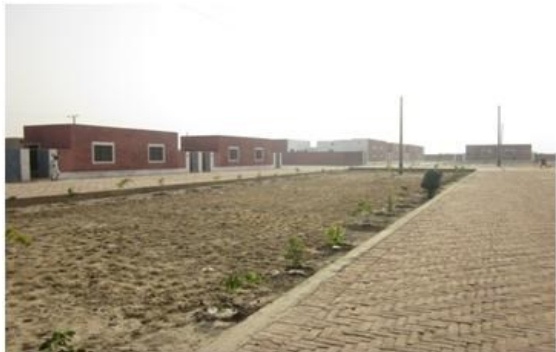
Fig. 7 Open space and brick paved street in Noor Ghazi
Source: Photograph by the Authors, 2011

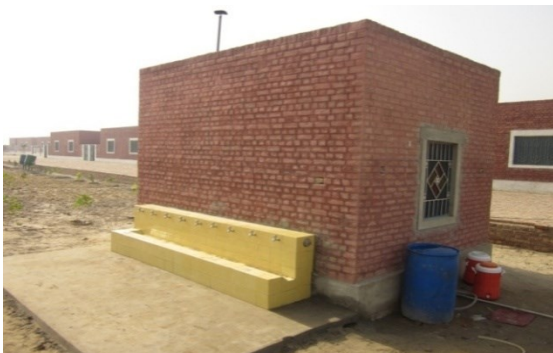
Fig. 8 Water filtration plant in Noor Ghazi
Source: Photograph by the Authors, 2011

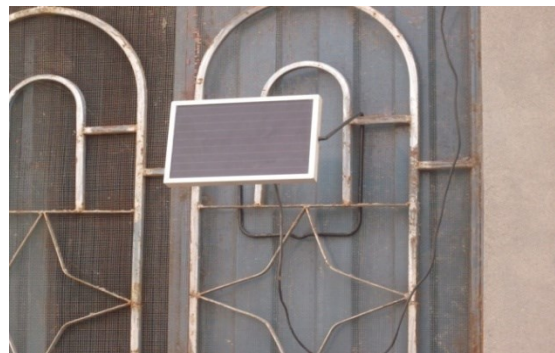
Fig. 12 Solar Cells outside houses in Noor Ghazi
Source: Photograph by the Authors, 2011

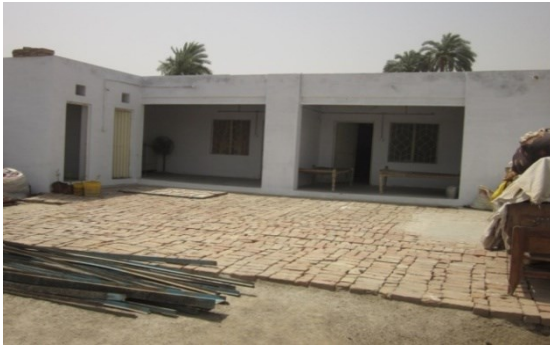
Fig. 14 Two room house in Miani Mallah
Source: Photograph by the Authors, 2011

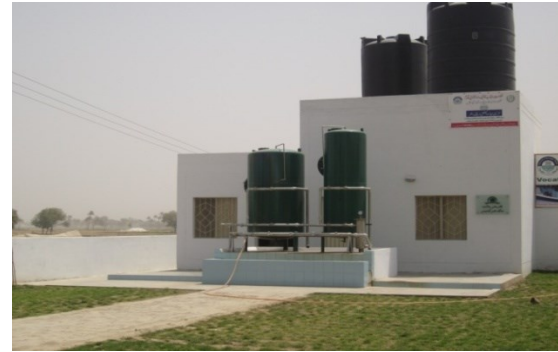
Fig. 18 Water filtration plant in Miani Mallah
Source: Photograph by the Authors, 2011

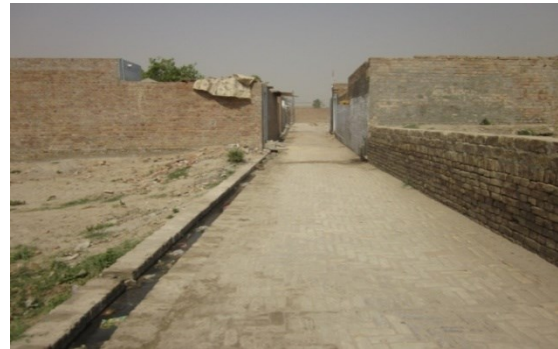
Fig. 19 Brick paved street in Miani Mallah
Source: Photograph by the Authors, 2011

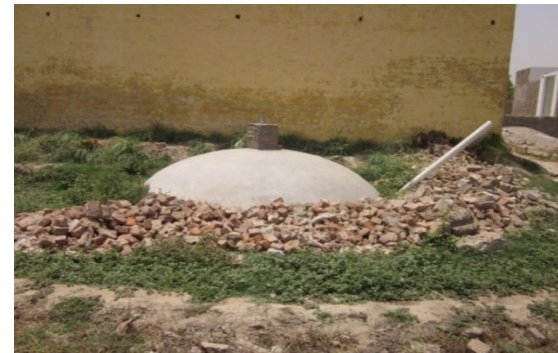
Fig. 20 Biogas plant in Miani Mallah
Source: Photograph by the Authors, 2011
