IMPROVING THE ENERGY EFFICIENCY OF EXISTING COMMERCIAL BUILDINGS IN LAHORE THROUGH RETROFITTING TECHNIQUE

R. Hameed¹, O. Nadeem^{1}, S. Altaf², F. Ameen³*

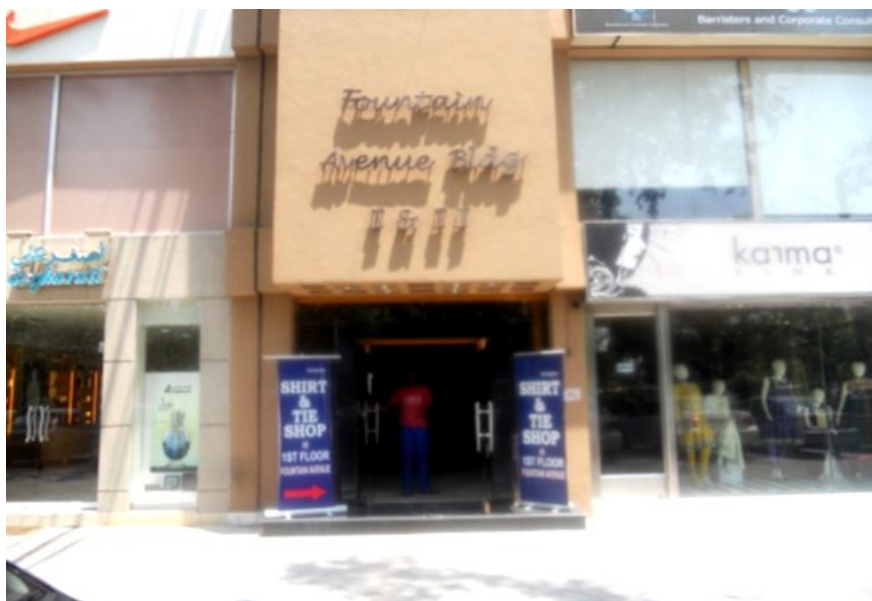
Figure 1: Facade of Fountain Avenue building I & II

It is a triple storey commercial building, built on a total area of four Kanals (18000 sq. m). There are roads on three sides and a building on the rear side. The building was constructed in two phases-first during 1980 and second in 1990. First part is called Fountain Avenue-I and the second one as Fountain Avenue-II. Its plan includes two basements and ground plus eight floors and a parking lot in front of the building. It has a ground floor and two upper floors accommodating 12 shops and 4 offices. All these 16 units were surveyed.

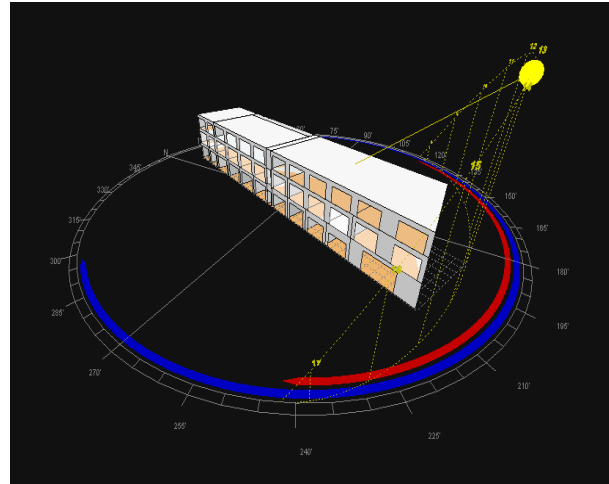
Figure 3: Sun path and position of the case study building during summer

Building is located at -110 degrees to north. The building has its front in North West direction; however its back is in South East direction. No uses are present on the north and south side except dead walls.

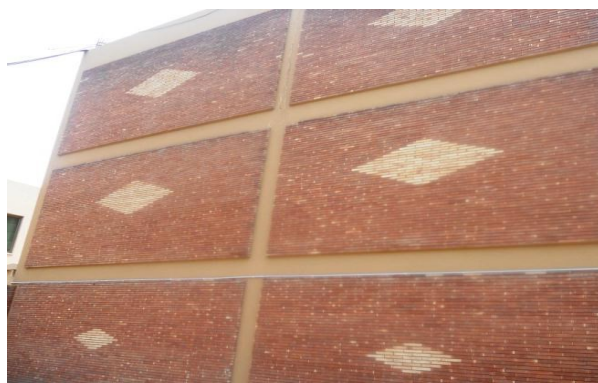
Figure 4: Northeast wall of Fountain Avenue building Figure 5: Windows on the left wall of first floor
Source: Photographs taken by the authors

Walls of the case study building are made up of red brick tiles which have been used on the outer face of the walls (Figure 4). Each tile is 9" inch long and 3 inch wide. Thickness of the outer walls is 9 inches while that of the inner ones is 4.5 inches. These are made up of cement-sand mortar. Every shop and office occupant has the liberty to make any changes within his premises.

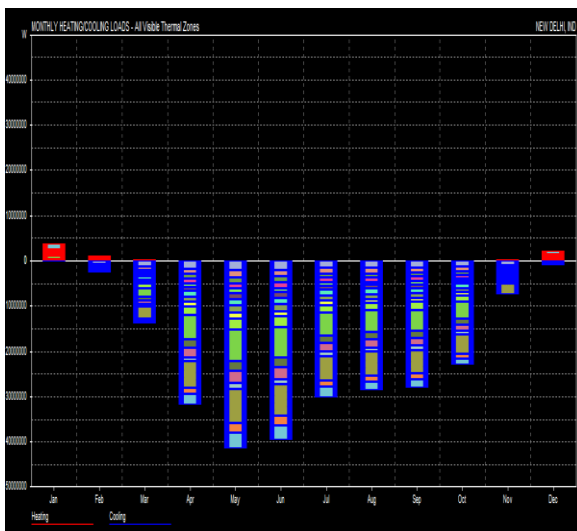
Figures 6: Monthly heating and cooling loads on building before retrofitting

The analysis of monthly heating and cooling loads using Ecotect software revealed that the maximum heating was required during the month of January and it used 3748130 Wh. (approx. 3748 KWh) energy. After the application of energy efficiency techniques (retrofitting) the required heating load dramatically reduced to 23418 Wh (approx. 24 KWh). The maximum cooling was required in May and it used 41544508 Wh (41544 KWh) energy (Figure 6). The cooling load reduced to 24190632 Wh (24190 KWh) after retrofitting (Figure 7).

The average monthly heating and cooling load of the existing building reached up to 21394138 Wh (approx. 21394 KWh), but reduced to 12555345 Wh (approx. 12555 KWh) after retrofitting. This implies that nearly 41% of the energy being used in the existing building can possibly be saved through the retrofitting techniques applied in this case.
